# BS 5837:2012 Arboricultural Survey

Wrexham Gateway Eastern Zone, Wrexham

**ISSUED:**  
25<sup>th</sup> June 2025

**PROJECT NUMBER**  
2025-05-573669

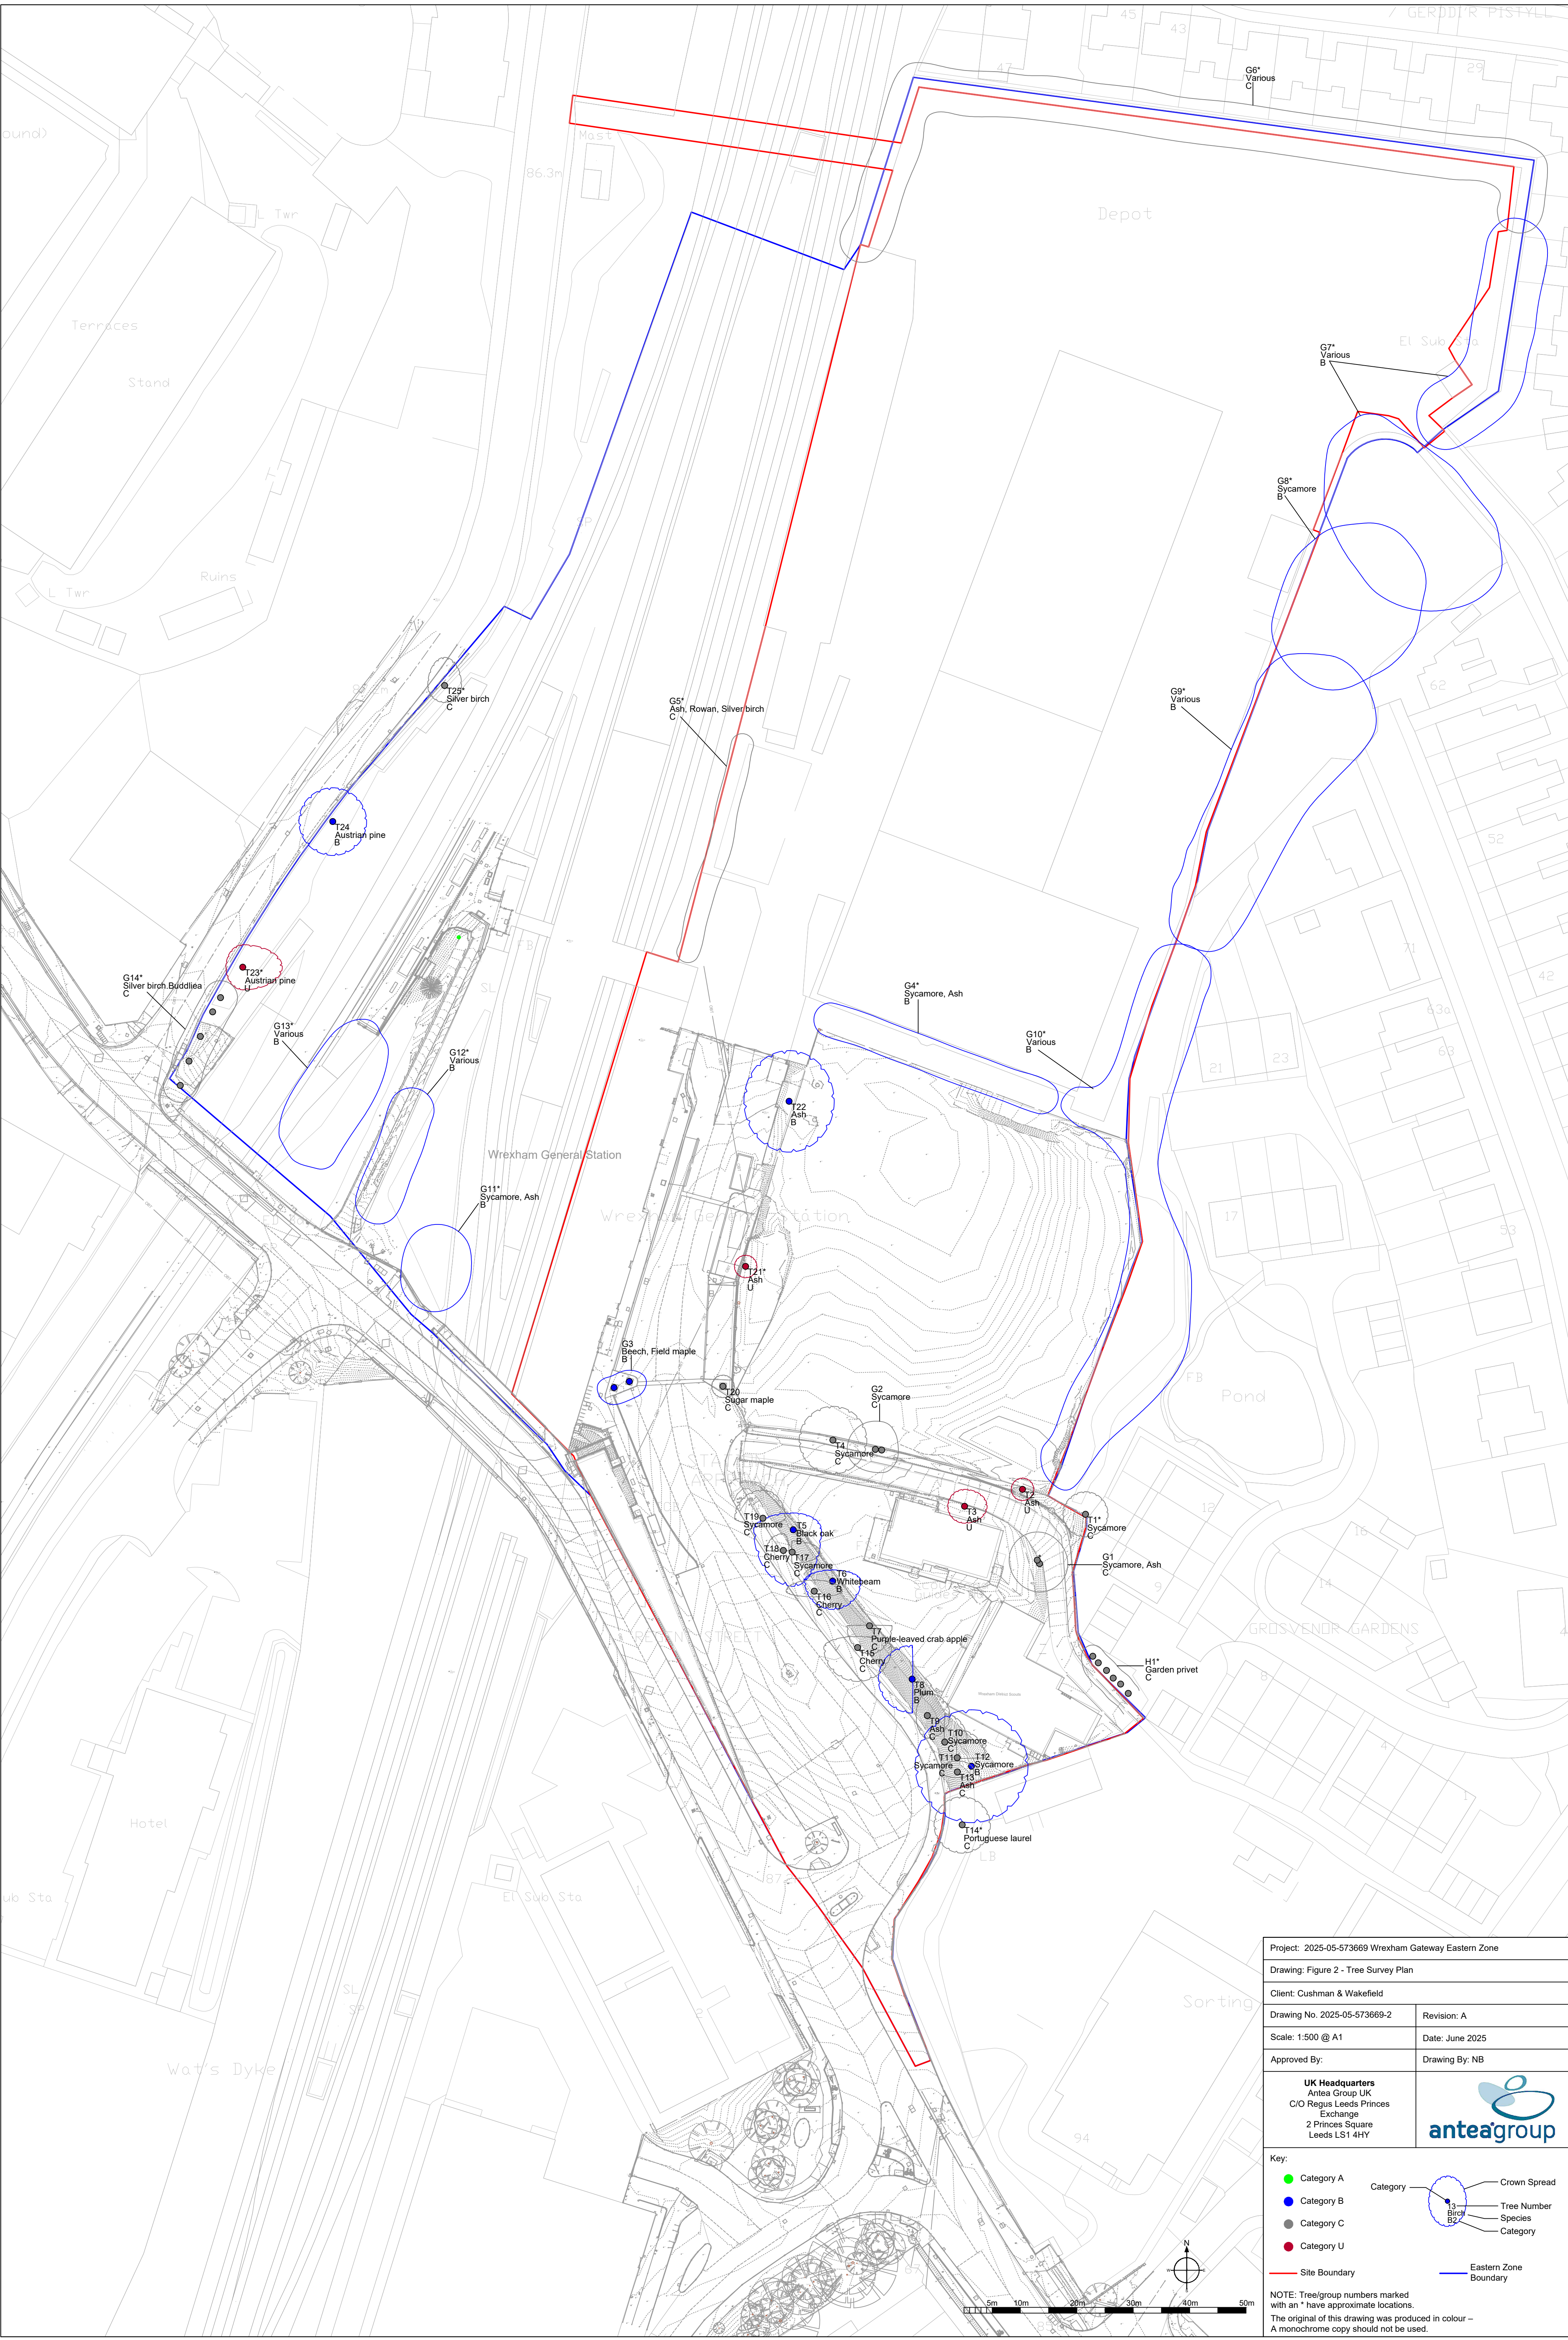
A total of 25 trees and 14 tree groups have been identified and assessed as part of the tree survey. All trees surveyed with the exception of six Tree Groups (TG) and five individual Trees (T) were within the Site boundary.

The trees present within the Site range from mature to young, with the majority semi-mature. A number of trees within the Site boundary show signs of past management, mainly in the form of canopy lifting and reduction where canopies extend over areas of vehicular or pedestrian accesses. The majority of on-Site trees appear to be in a fair condition. A number of ash trees (T2, T3, T21) display signs of ash dieback disease *Hymenoscyphus fraxineus* while an Austrian pine (T23) had a severely damaged main stem.

- Trees T2, T3 and T21 all display signs of ash dieback and should be removed and a suitable replacement planted; and
- Tree T23 has a severely damaged main stem and should be removed and a suitable replacement planted.

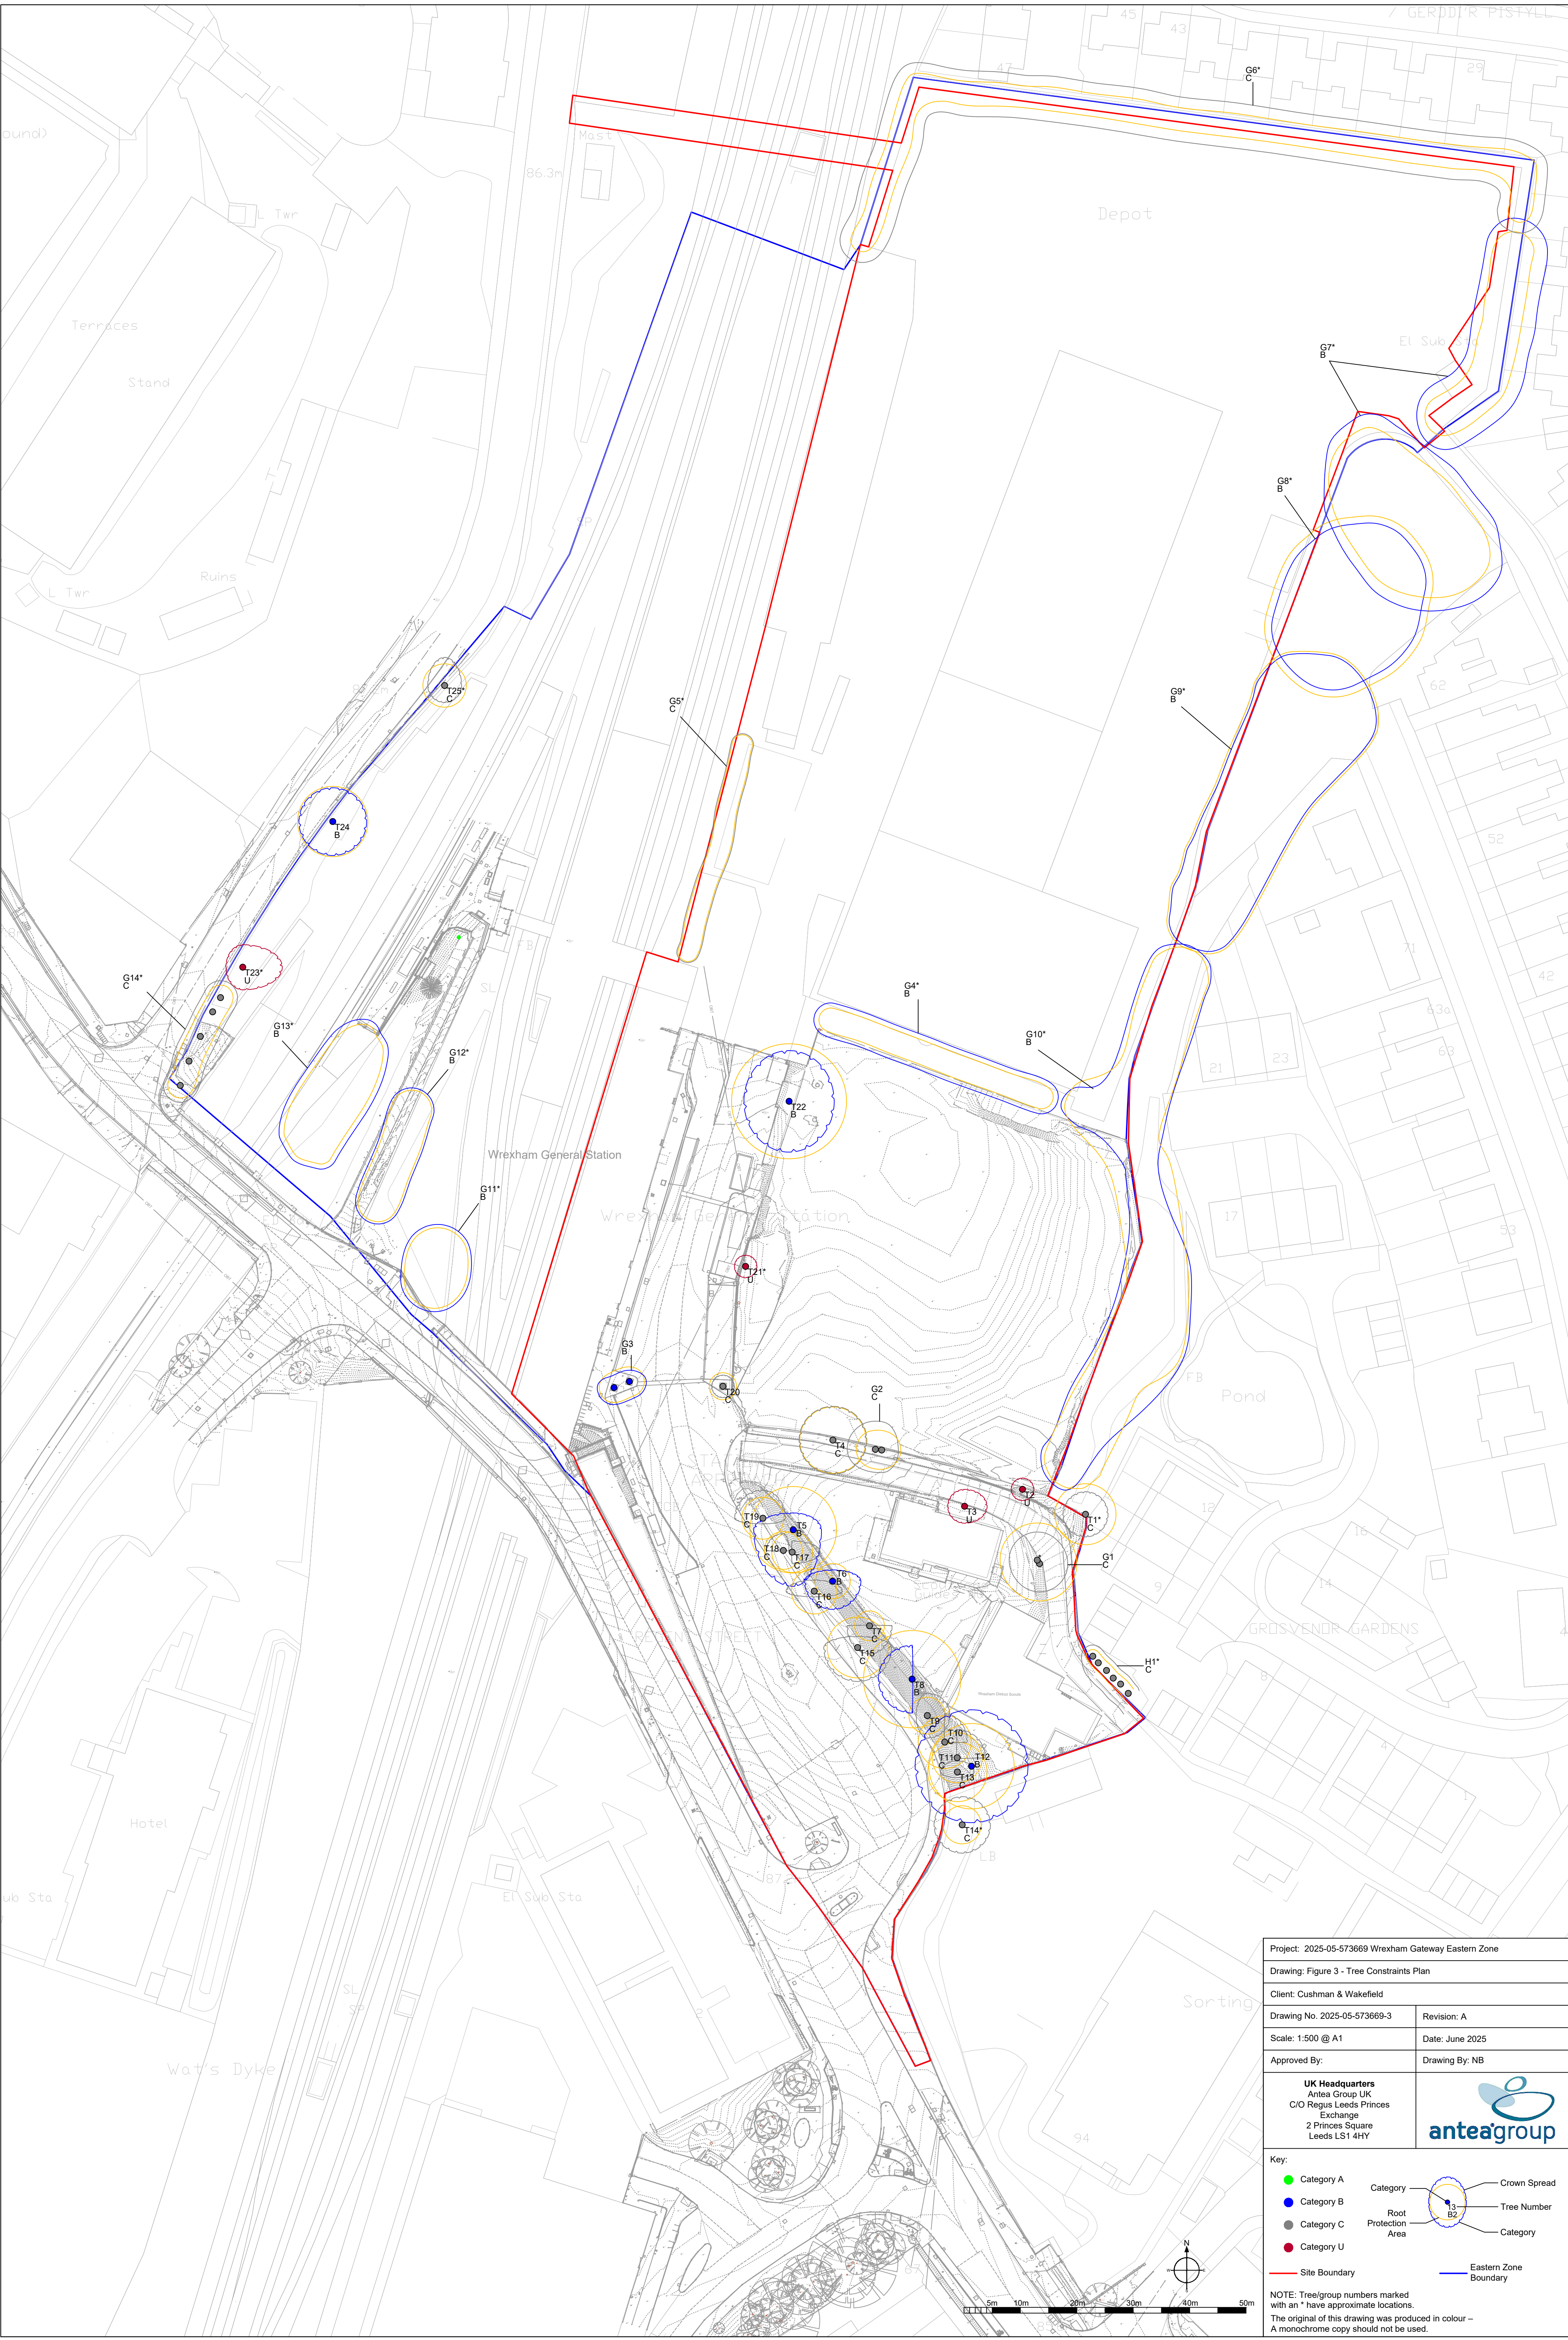
The extent and positions of significant individual trees or groups of trees close to the Site are shown on the Arboricultural Survey Plan (Figure 2). The Root Protection Areas (RPA) of the key trees of value identified for, or recommended for, retention have been marked within the Constraints Plan (Figure 3) using the RPAs provided in the Tree Schedule within Table 1.
