Wrexham Gateway, Wrexham

Sites A and B (Application Site) Phase 1 Desk Study

3 July 2025

Wrexham County Borough Council

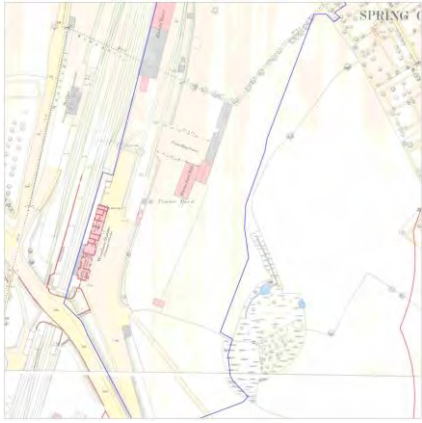
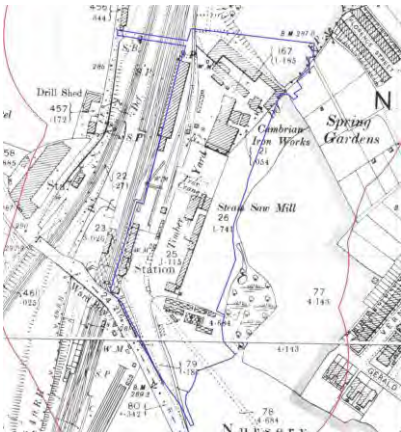
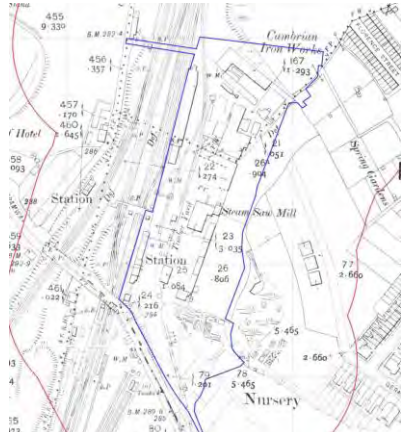
1874 – 1:1,000	1899 – 1:2,500	1912 – 1:2,500

<p>Earliest available mapping indicates the western half of the site consists predominantly of buildings, platforms, tracks and worked ground associated with <i>Wrexham General Station</i>. Railway sidings are present, potentially also including a <i>turntable</i>, <i>Goods Shed</i> and a <i>travelling crane</i>. The eastern half of the site contains worked ground associated with the station approach and a <i>timber yard</i> and adjacent <i>steam saw mill</i>. A footpath crosses the southeastern portion of this area trending northwest to southeast, but the land is otherwise undeveloped, as is the land in the northeast of the site. What appears to be boggy ground with a watercourse and pond immediately bounds the eastern edge of the site.</p>	<p>By 1899, further buildings associated with the <i>steam saw mill</i> have been constructed along the eastern boundary of the <i>timber yard</i> (eastern side of the site). A previously undeveloped piece of land to the southeast of the site now contains a cluster of rectangular buildings, possibly associated with a <i>nursery</i>. Several buildings have been constructed on the previously undeveloped land in the northeast corner of the site associated with <i>Cambrian Iron Works</i>. The narrow section of the site boundary to the northwest associated with a proposed footbridge can be seen to be crossing railway sidings and tracks including earthworks associated with these, some small buildings are within the footprint of this area.</p>	<p>There is a new platform at Wrexham General, as well as a modification to the bridge linking the platforms, moving the bridge from the southern edge of the site along the A541, further north to the northern side of the station buildings. A tramway is shown along the A541/Regent Street.</p>

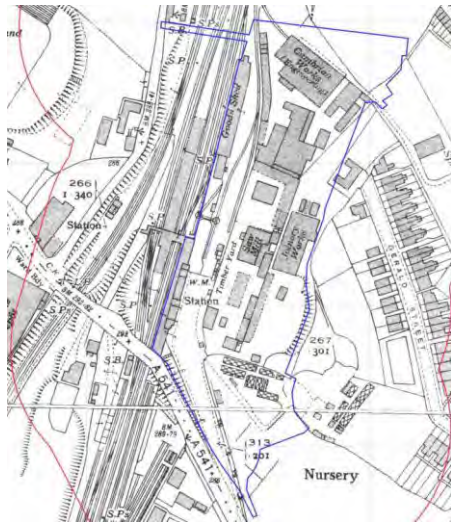
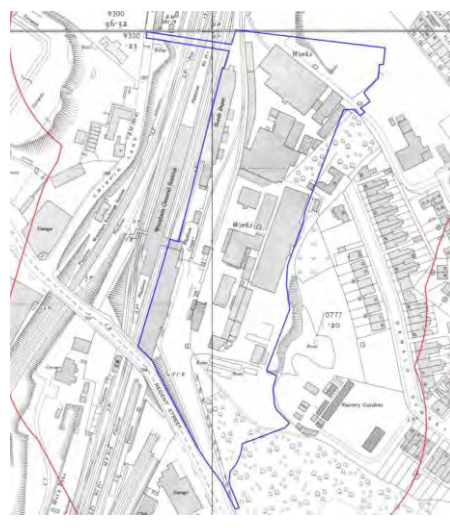
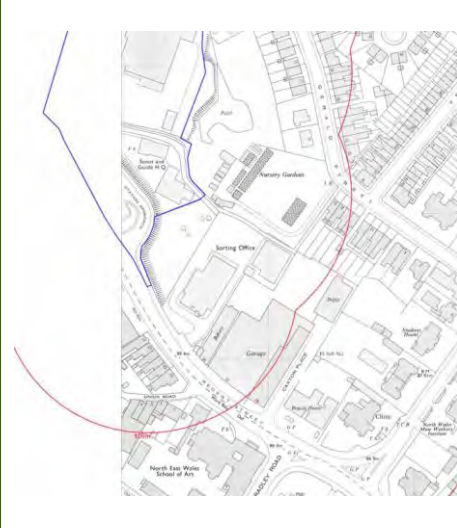
1937 to 1939 – 1:2,500	1960 – 1:2,500	1963 to 1968 – 1:1,250 (Partial Coverage)

<p>The number of buildings present within the timber yard has increased; this also shows the mapped extents of worked ground along the eastern boundary of the site. An additional building has been constructed in this area as well labelled <i>Joinery Works</i>. The number of buildings associated with <i>Cambrian Iron Works</i>, now <i>Cambrian Works (Engineering)</i>, has increased and the configuration modified.</p>	<p>The number of buildings within the <i>timber yard</i> which has now been labelled as <i>Works</i> has increased. The buildings just south of this area previously assumed to be associated with a <i>nursery</i> are now labelled as <i>ruins</i>. The previous position of a possible turntable at the western edge of the site has been replaced by a <i>platform crane</i>. The number of buildings and their configuration at the location of <i>Cambrian Works (Engineering)</i> has been modified and the name <i>Cambrian Works (Engineering)</i> is no longer given. Some worked ground is now mapped in contact with the northern site boundary.</p>	<p>The ruins marked in the southeast corner of the site and some woodland has now been replaced by two new buildings marked as Scout and Guide HQ. The position of the footpath in this area has now been diverted north between the timber yard and new buildings. The area of worked ground associated with the station approach has been expanded/widened. A much larger building (possibly a warehouse) now occupies much of the former timber yard.</p>

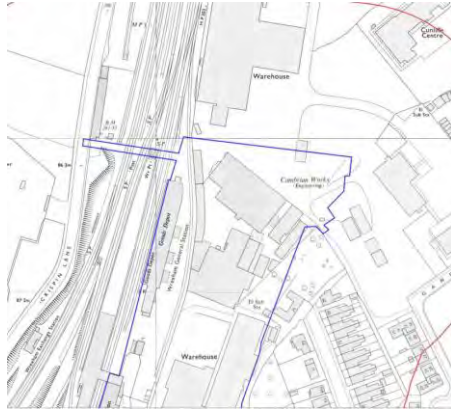
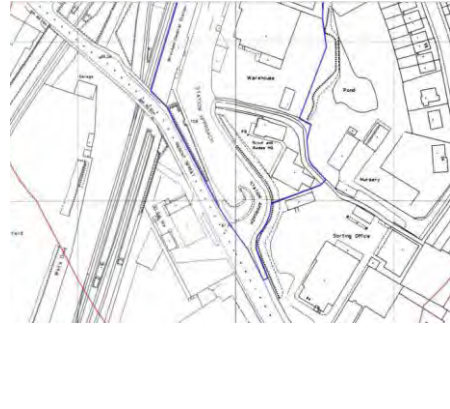
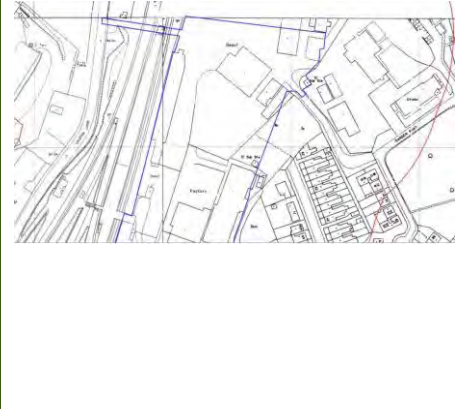
1968 to 1973 – 1:1,250 (Partial Coverage)	1989 to 1992 – 1:1,250 (Partial Coverage)	1992 to 1994 – 1:1,250 (Partial Coverage)

<p>The former timber yard now appears to have been replaced by a larger building associated with a warehouse complex that is present within the northeast of the site. The number of railway sidings in this area appears to have decreased and the platform crane has now been removed. The extent of the station building appears to have been reduced along the central platform area. An <i>electrical substation</i> is now noted northeast of the <i>Warehouses</i>.</p>	<p>No notable changes from previous.</p>	<p>Sidings within the northeast of the site have now been removed. A number of buildings associated with the former <i>Cambrian Works</i> have now been removed and replaced with a building labelled <i>Depot</i>. An additional <i>Electrical Substation</i> is now present within the northeast corner of the site. The configuration of buildings adjacent to the northwest edge of the site have now changed.</p>

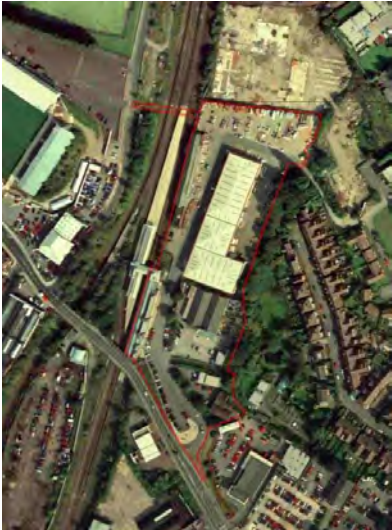
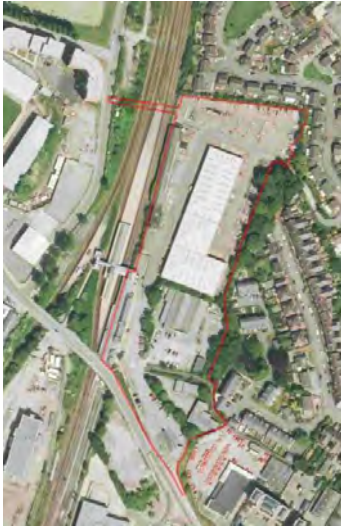
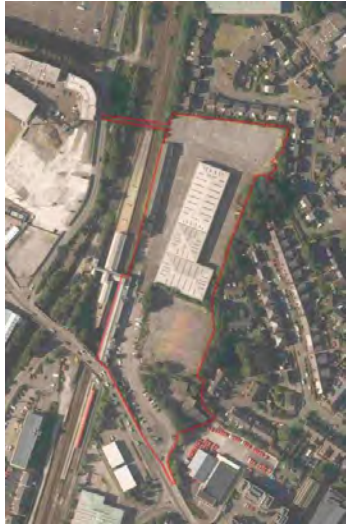
2000 – Aerial Photography	2013 – Aerial Photography	2023 – Aerial Photography

Car parking can be seen to the south of the site along the edge of the station approach; the structures remain in a similar layout to previous mapping, with the exception of the warehouse buildings within the centre and north of the site, removal of the <i>Depot</i> building and Wrexham Exchange station building to the west of the site which has now been removed.	There appears to have been some modifications to the cut slope in the former location of the Wrexham Exchange station building.	The warehouse structure and yard present within the southeastern corner of the site has been demolished and removed.

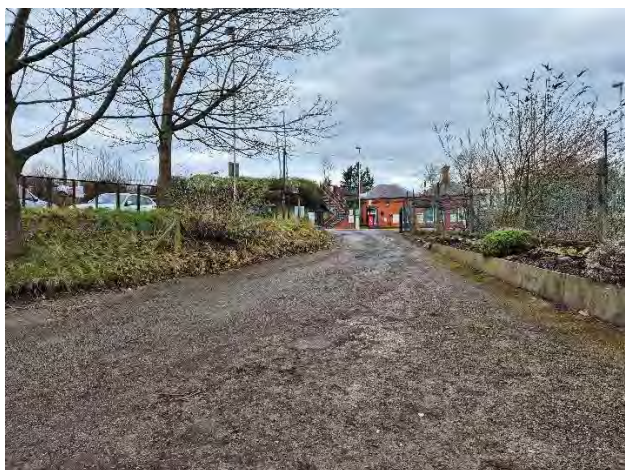
3. Entrance to guide and scout huts, facing west.

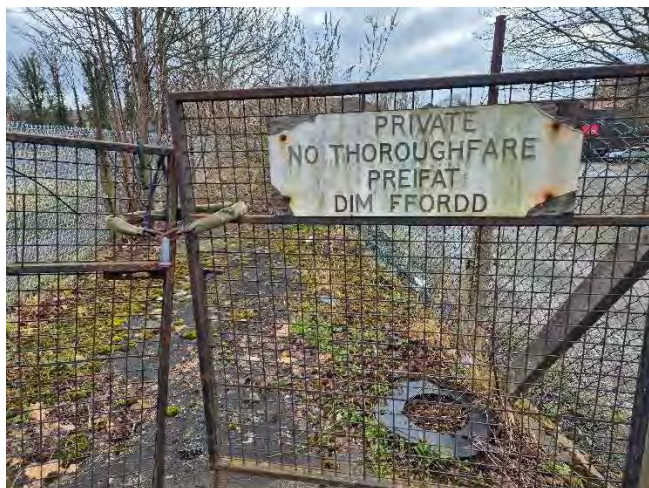
5. Inaccessible path to north of scout hut, facing east.

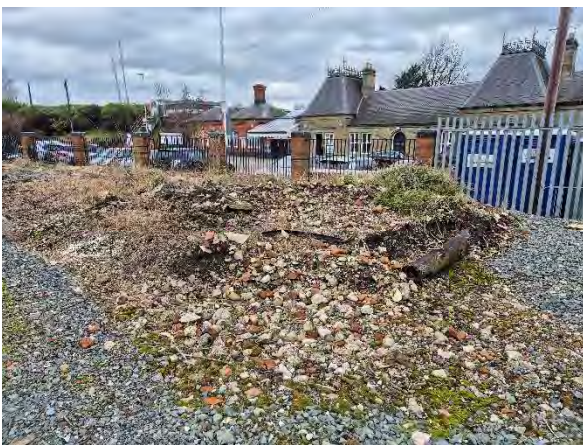
17. Vacant plot showing demolition material and vegetation on west edge, facing southwest.

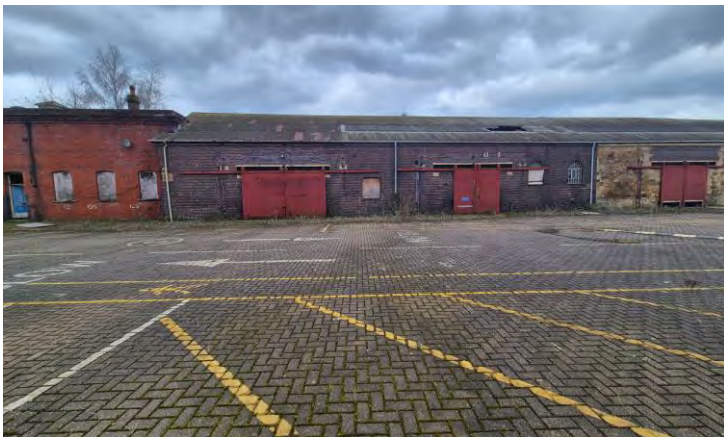
3. View showing extent and condition of former goods shed buildings, facing west.

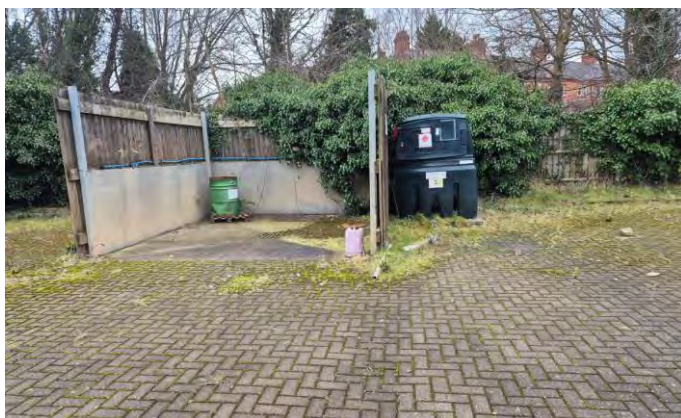
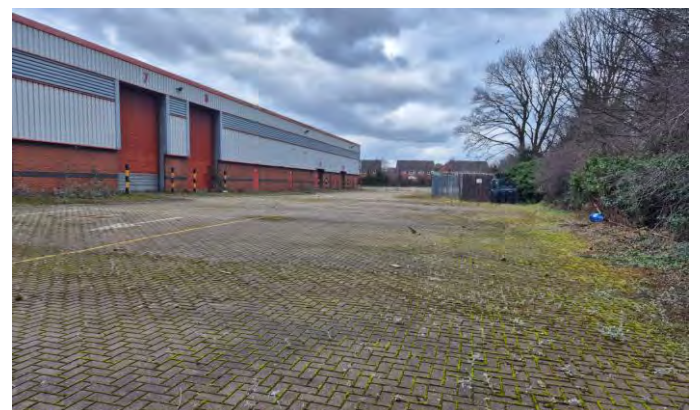
| <p>11. Former area of unknown purpose containing metal and wooden fencing, a water pipe, plastic and metal drums of unknown materials/chemicals, an above ground storage tank for UN1202 (gas oil/diesel) with a lock, possibly up to 1400L but unconfirmed, facing east.</p> | <p>12. View back across service yard towards above ground storage tank (assumed to not be banded), blue metal container of unknown substance is present facing northeast.</p> |

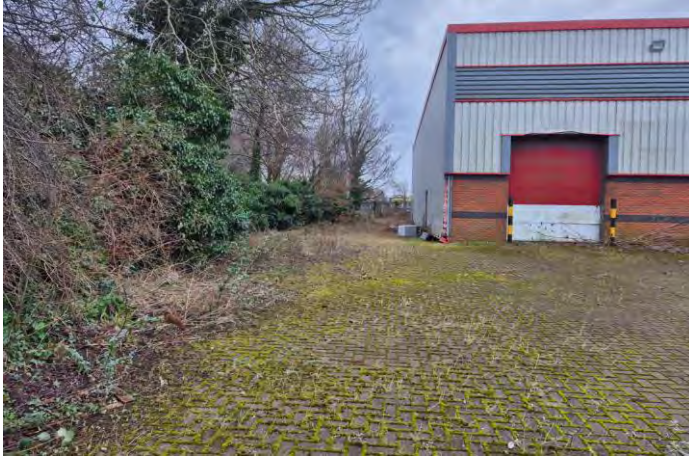
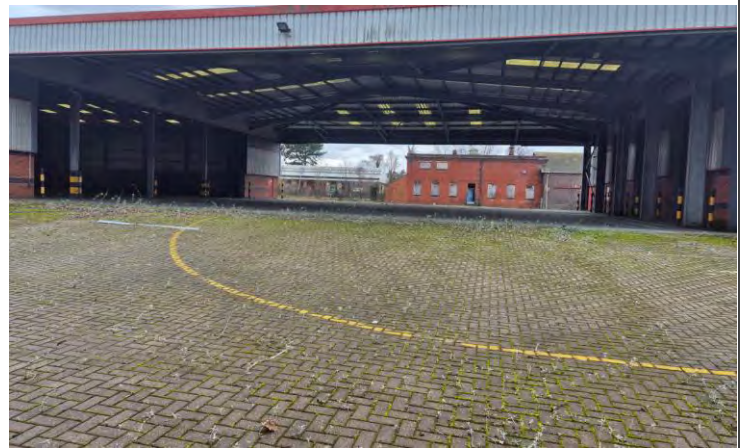
| <p>13. View along southeastern edge of former Jewsons warehouses with potential fly tipped fridge visible. Damage to external elements of building visible including the exposure of pink coloured foam assumed to be insulation and damage to the top of the frame around shutter doors, facing south.</p> | <p>14. View across service/delivery bay area towards former goods sheds, facing west.</p> |
