# BS 5837:2012 Arboricultural Survey

Wrexham Gateway Eastern Zone, Wrexham

**ISSUED:**  
25<sup>th</sup> June 2025

**PROJECT NUMBER**  
2025-05-573669

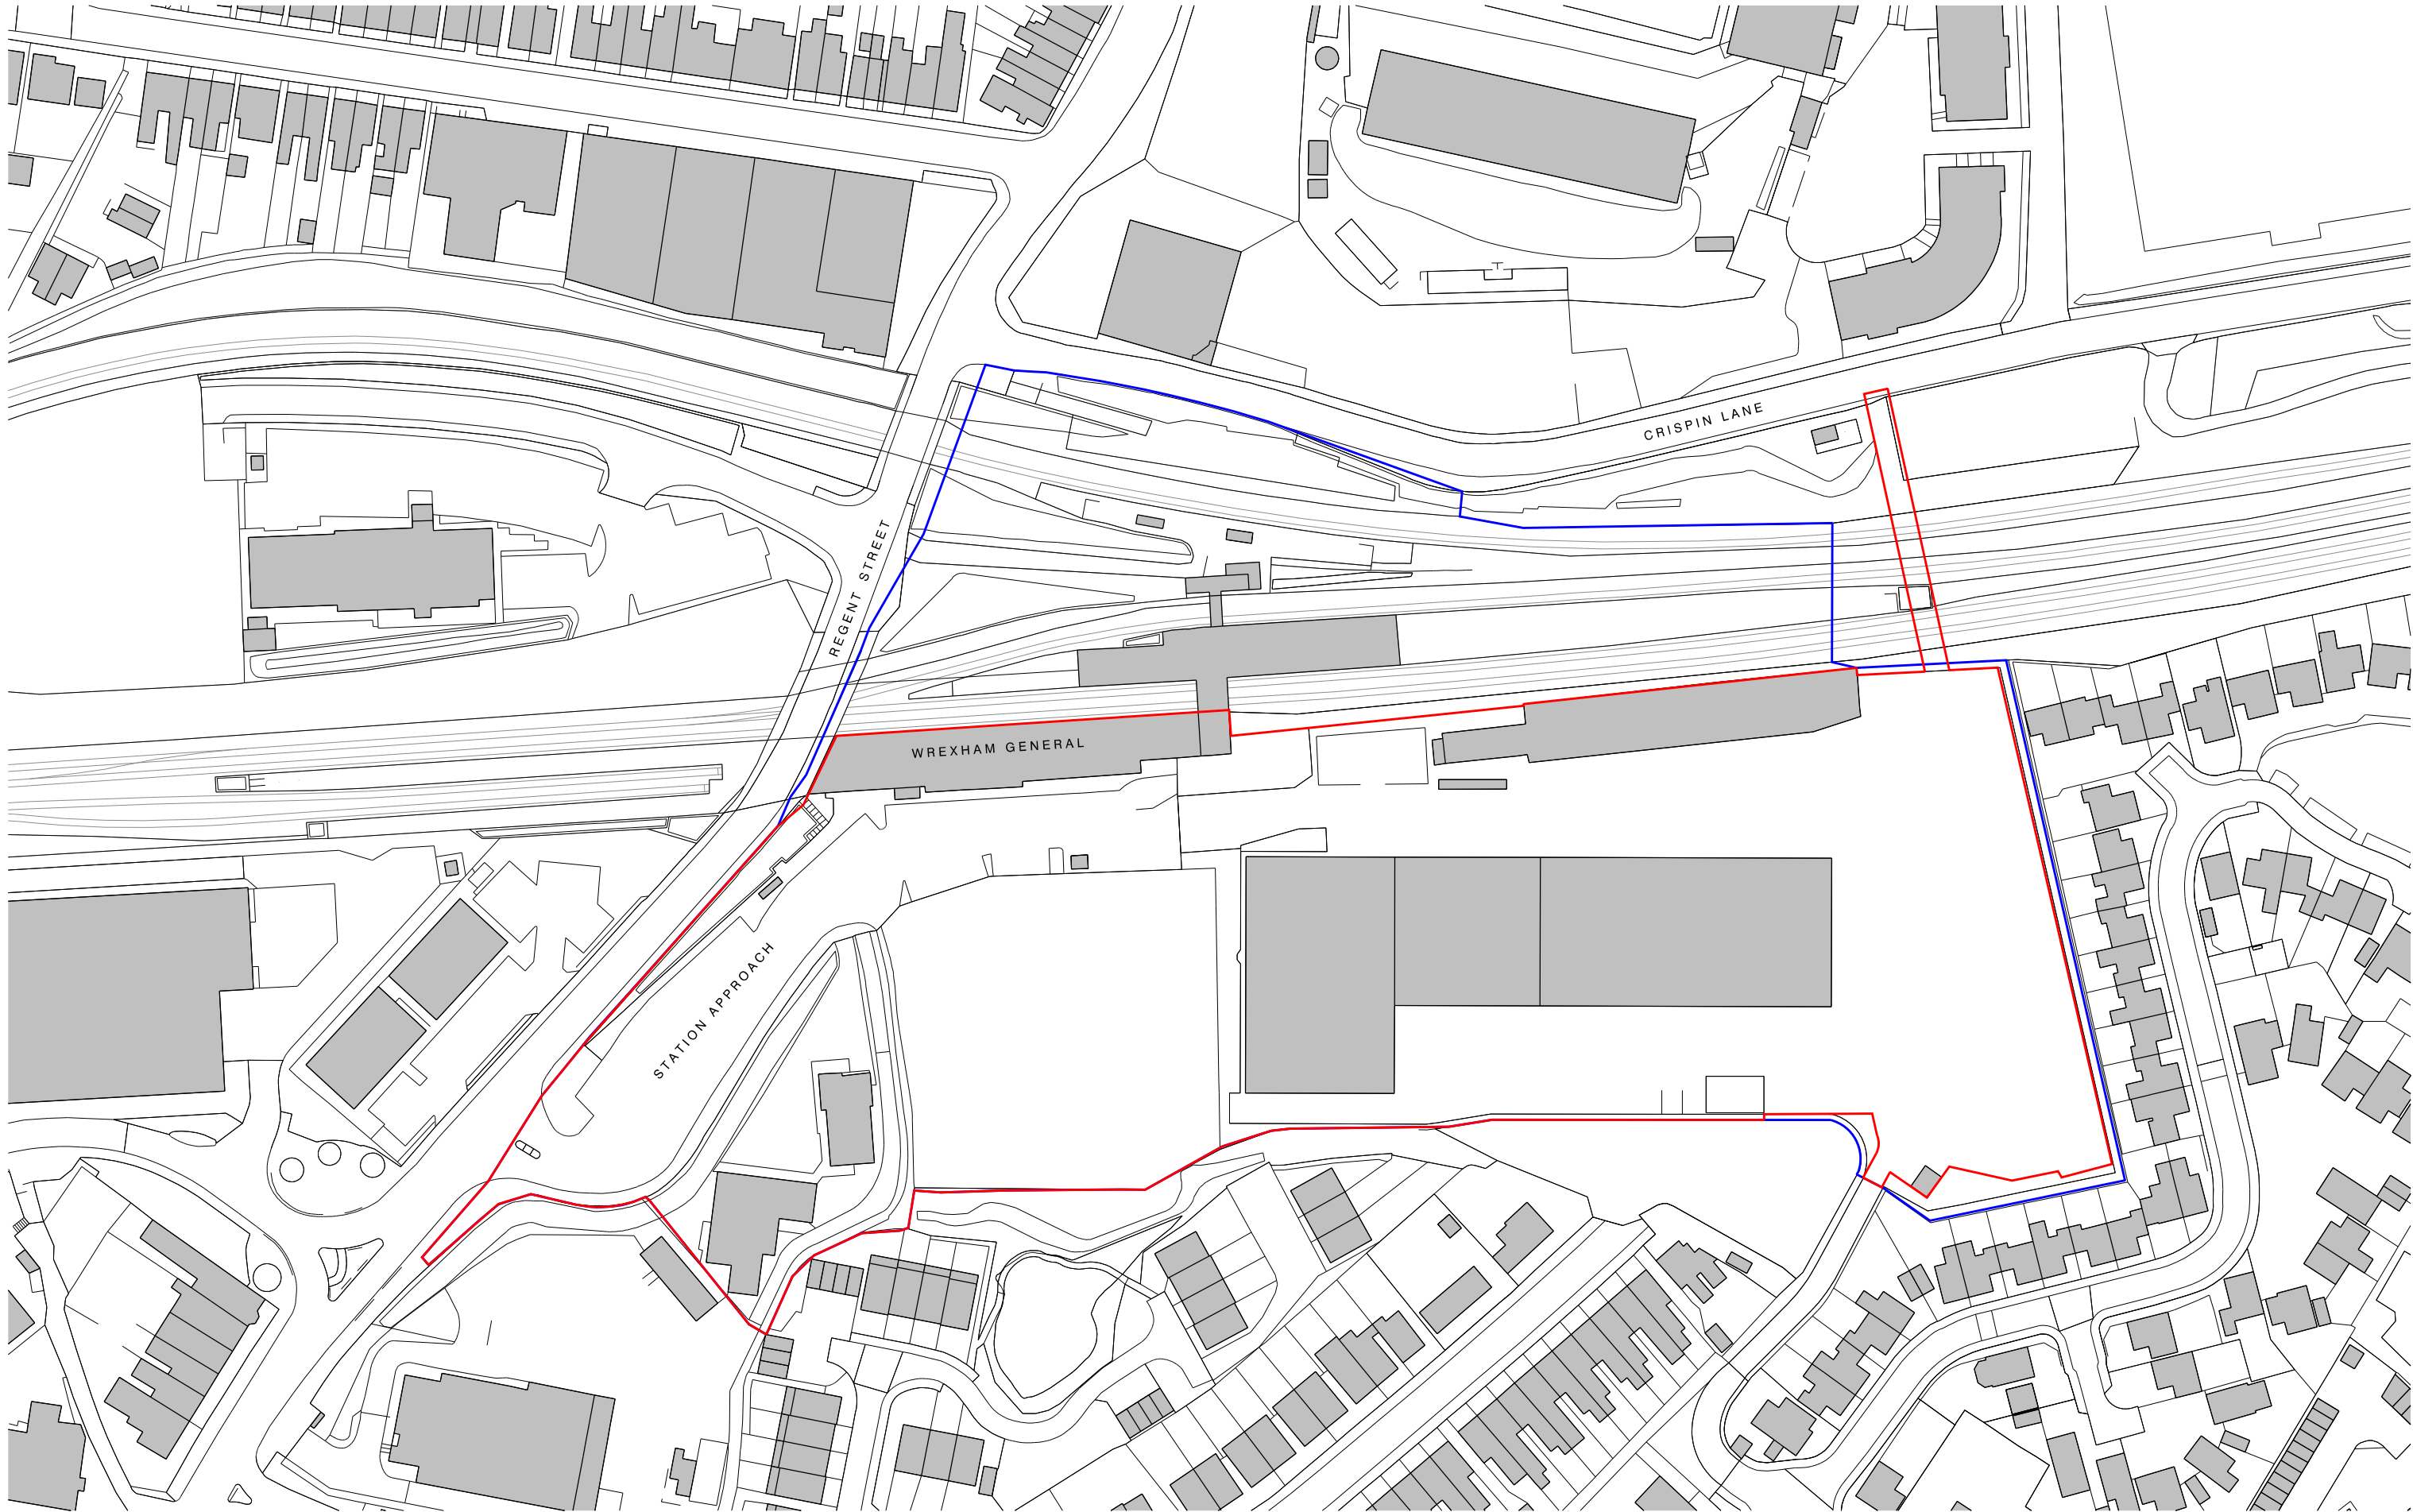
Figure 3 – Tree Constraints Plan

The extent and positions of significant individual trees or groups of trees close to the Site are shown on the Arboricultural Survey Plan (Figure 2). The Root Protection Areas (RPA) of the key trees of value identified for, or recommended for, retention have been marked within the Constraints Plan (Figure 3) using the RPAs provided in the Tree Schedule within Table 1.
